Pitfalls of Biocontainment Facility Projects and How to Avoid Them

Expert Says More Than Half of all Biocontainment Labs are Incorrectly Constructed

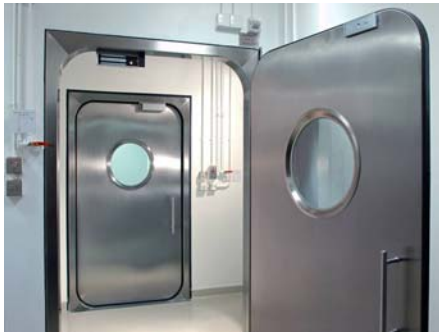
Description: This large airlock at the University of Hong Kong features air inflatable door seals that are flush with the floor.

Pitfalls: If the door seal is not flush with the floor (such as with pressure seal doors of the submarine type) then equipment has to be rolled over the lips, damaging the bottom of the door and risking employee back injury.

Suggested precautions: Design with ergonomics in mind. Use doors that are flush with the floor, consider optimal durability, and be certain that doors meet regulatory and containment requirements.

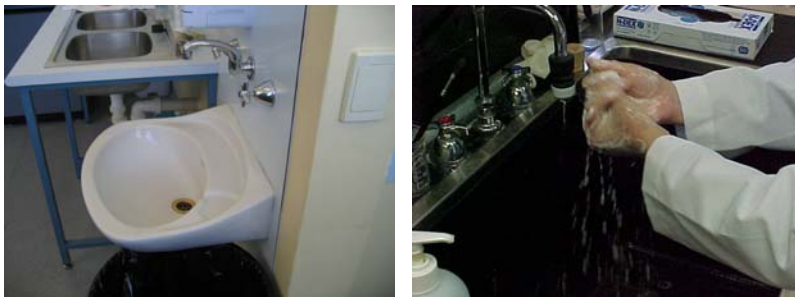
Description: Hands-free sinks are required at the exit of the laboratory.

Pitfalls: Handles do not make these sinks truly hands-free. Sinks placed inside the airlock can contaminate the airlock; sinks placed outside of the laboratory can spread contamination. Lab coats are not suitable for BSL-3 facilities because they form a risk of contamination of the wearer if there is a spill of infectious material.

Suggested precautions: Use hands-free sinks that are truly hands-free. Don't locate sinks in airlocks or outside of laboratories. A hands-free sink needs to be at the exit of each laboratory and its water supply, which is part of the potable water supply, must be separated from the laboratory water. Provide users with back fronted lab gowns with long sleeves, elasticized cuffs, and gloves that overlap the top of the cuffs.

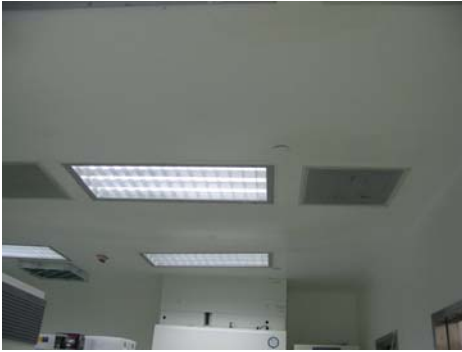
Description: This ceiling is collapsing due to higher negative air pressures than the materials can resist.

Pitfalls: Walls and ceilings that are not designed to withstand positive pressure leak tests or negative room pressures, such as dry plaster board construction, can move or collapse breaking the secure barrier.

Suggested precaution: Select materials and construction with positive pressure leak test and negative room pressures in mind, such as sandwich panel construction as used in cleanrooms or cold rooms.

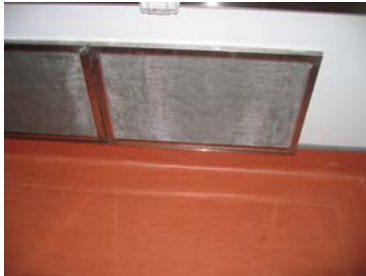
Description: Terminal HEPA filters.

Pitfalls: These filters, based on a cleanroom design, draw potentially contaminated air across the worker and are difficult to decontaminate and test.

Suggested precautions: Mount HEPA filter canisters on the floor above, with ducts entering from the ceiling. Locate the supply vent near the entry door and the exhaust vent on the other side of the room to ensure directional airflow away from the door. The HEPA filter canister should contain the HEPA filter, a pre-filter, access for scanning the filter, bubble tight dampers at each end, and ports for decontamination of the HEPA filter without having to also decontaminate the laboratory.

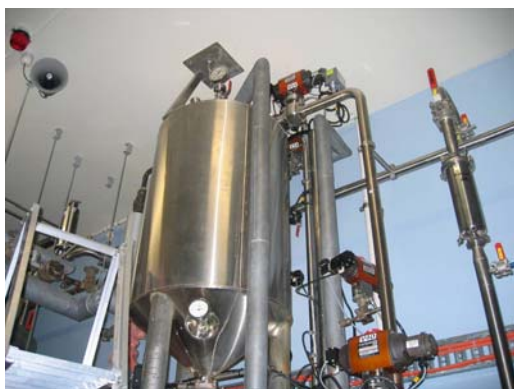
Description: This boiler is mounted too high, with a burst disk near the top.

Pitfalls: When the boiler is mounted too high, it is extremely difficult to service. Lag spots are present, and temperature probe testing reveals poor circulation.

Suggested precaution: Mount boilers where they will be easy to monitor and service.

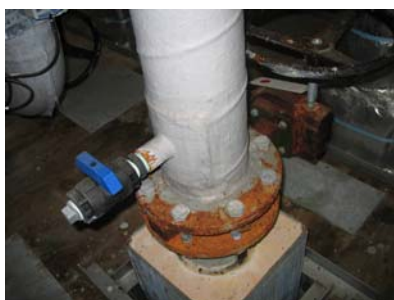
Description: Room humidity and cool air temperature causes condensation of water on non-stainless-steel pipes, causing rust.

Pitfalls: Inferior materials were used, instead of stainless steel and the plant room was not conditioned to remove humid air, which condenses on the cold air ducts.

Suggested precaution: Use stainless steel and condition the plant room.

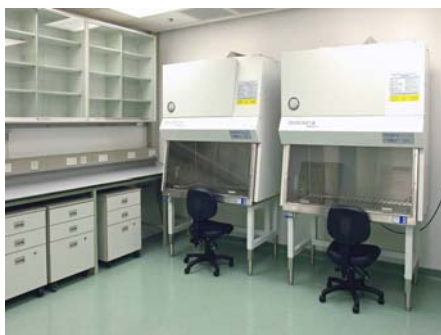
Description: This laboratory is properly designed.

Key elements: Moduline ducting carries power and communication cables around the walls, which prevents unsealed penetrations and allows additional communication points to be added later without breaking the facility's air seals. Normal outlets can then be used instead of airtight outlets, which can be up to 40 to 50 times more expensive.

Ergonomically designed biological safety cabinets should sit low enough to allow the user's feet to rest on the ground thus supporting the back and shoulders and reducing over-use syndrome injuries caused from stretching into the safety cabinet to work. The system should allow users to be able to see the pressure gauge (Magnehelic gauge recommended) so that they are aware of what pressure alarms mean in their laboratory. Power outlets that are switchable outside the facility should allow the decontamination process to be turned on and off.

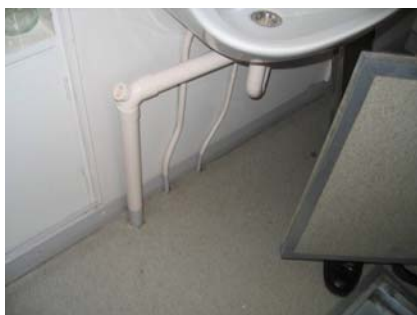
Description: Unsealed floor without coving.

Pitfalls: Visible holes reveal non-waterproof outlets that are not airtight, preventing hosing down. Improperly sealed retrofitting is another common problem.

Suggested precaution: Properly seal walls, floors, and equipment. Extend floor covering at least six inches up the walls (coving).

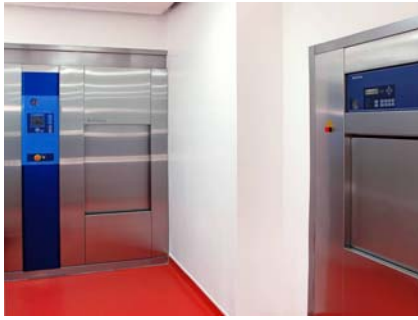
Description: Properly sealed double-ended bioseal autoclave.

Key elements: Maintain a barrier to seal the autoclave. Install a vent filter on the vacuum and contain condensate. Ultracentrifuges require a HEPA filter between the chamber and the vacuum pump to contain infectious material in case of an accident.
